# Manhole Inspection Summary

Manhole # S31AA\_014MH

Insp Date: **12/14/07 3:11 PM**

**Location** Address: **801 MOORE ST**

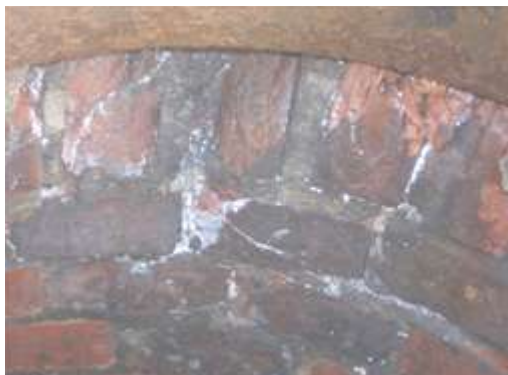
Defect 4

Condition: ☐ Sound ☐ Cracked ☐ Root Intrusion ☐ Loose Brick ☒ **Deteriorated**

CHIMNEY DETERIORATION

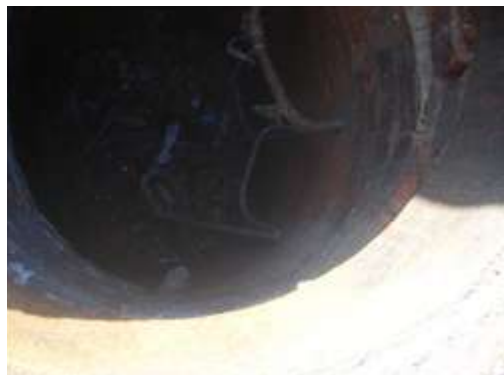
Defect 3

Count: **4** Missing: **0** ☒ **Corroded**

☒ **Evidence Of Surcharge** Depth: **3** (ft.) ☐ Active Surcharge Present

CORRODED STEPS AND SURCHARGE  
EVIDENCE ON STEPS

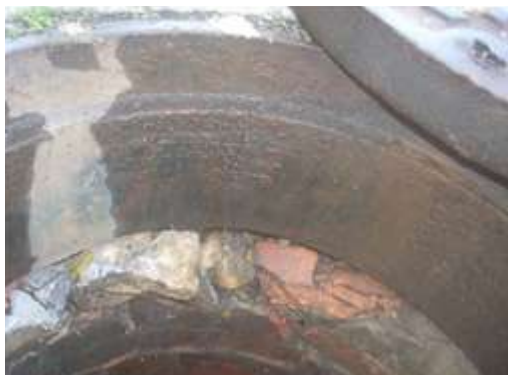
Defect 2

CHIMNEY DETERIORATION

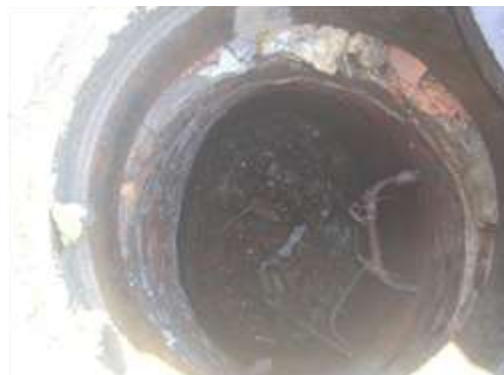
Defect 1

Offset: **1.5** (in.)

Condition: ☐ Sound ☐ Cracked ☐ Root Intrusion ☐ Deteriorated ☐ Leaks ☒ **Debris**

FRAME OFFSET/ DEBRIS

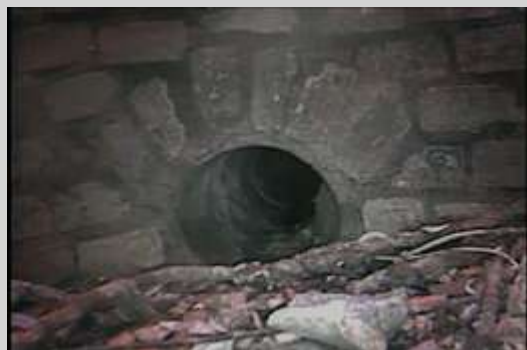
12 O'Clock Outflow

Deposits: ☐ None ☐ Mud ☒ **Sludge** ☐ Debris ☐ Grease

Silt Depth: **1** (in.) Deposits Extent: **Light**
